Shoreline Change Analysis of Pontang Cape of Serang Regency of Banten Province

Abdurrahman Al-Farrizi^{1*}, Ankiq Taofiqurohman², Subiyanto Subiyanto²

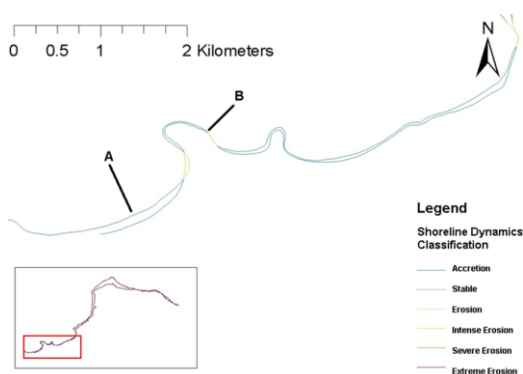
Figure 2. Visuaization of Study Area I

The research area was divided into two study areas, named Study Area I (Figure 2) and Study Area II (Figure 3). Separation into two study areas was done on the basis that in different parts of the coastline, there were differences in the dynamics of the coastline that became dominant. The dominant shoreline dynamics in Study Area I (including Sawah Luhur, Sukajaya, and Linduk villages) were accretions, while Study Area II (consisting of Wanayasa, Domas, Pontang, Lontar, Sujung, and Ciujung river estuaries) was dominated by abrasions.

The Study Area I had a total length of 7047.97 meters, dominated by accretions of

6541.93 meters (92.82 %). The Study Area II had a total length of 17545.6 meters, with most of the coastline were damaged by extreme erosions (coastal erosion more than 5 meters per year), being 11938.67 meters (68.05 %). The total length of the observed coastline was 24593.57 meters. Percentages of coastline lengths based on changes that occurred are tabulated in Table 2.

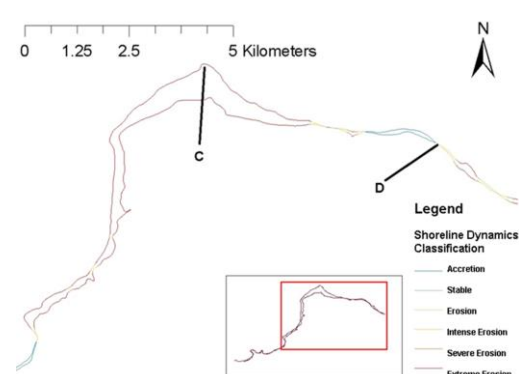
Figure 3. Visuaization of Study Area II

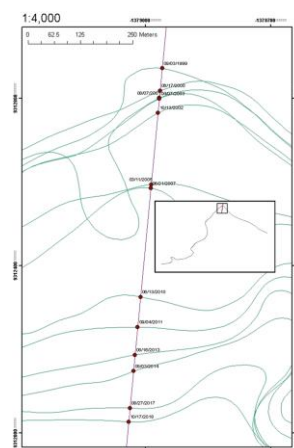
Figure 6. Transect C and its intersection points with the shorelines

From the calculated transects in Study Area I, the greatest accretion occurred in transect A (Figure 4). The smallest accretion distance over 19 years was observed in transect B (Figure 5). Both transects A and B were on the coast of Sawah Luhur village. In Study Area II, the largest abrasion was recorded in Transect C (Figure 6). The smallest

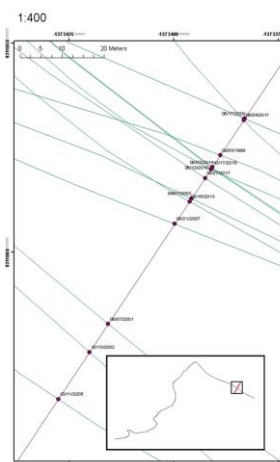
Figure 7. Transect D and its intersection points with the shorelines

abrasion was measured in Transect D (Figure 7). Transects C and D were respectively in Pontang Cape and east of Lontar Village. The results of the calculation of distance, rate, and coefficient of determination of the transects were tabulated in Table 3.

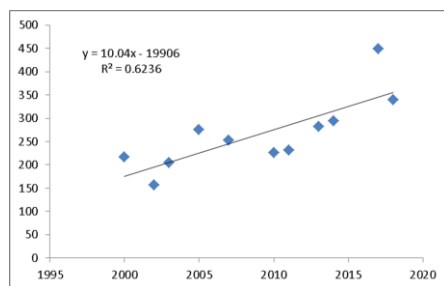
Figure 8. Linear regression of Transect A

The results of the calculations of linear regressions between year increments with changes in coastline distances from the baseline for the maximum and minimum accretions respectively showed moderate and weak correlations (R^2 values = 0.6236 and 0.048, Figure 8 and 9). The value of R^2 of Transect B which was almost zero showed that there were no relations between the increase of years with the progress of the coastline, or the accretion had no effect on the Transect B. The regression results between the decline of the coastline to the year change for the largest abrasion distance and the smallest (Transects C and D) had R-squared values of 0.9779 and 0.1068, respectively (Figure 10 and 11); indicated a very strong correlation and a weak correlation between abrasion and changes in years in each place. Correlation of abrasion with a change in years was greater than the correlation between accretion with a change in

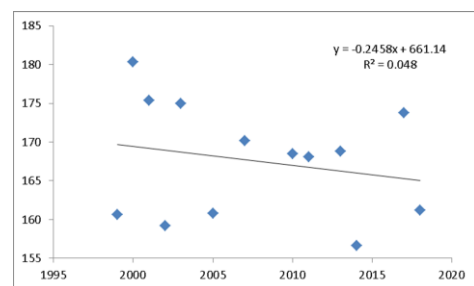
Figure 9. Linear regression of Transect B

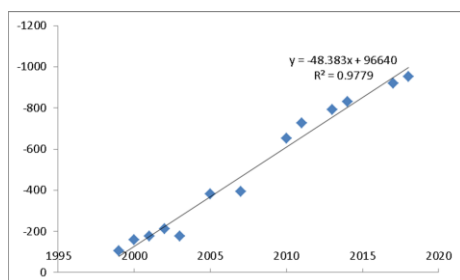
Figure 10. Linear regression of Transect C

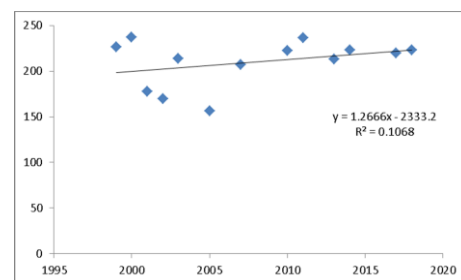
Figure 11. Linear regression of Transect D

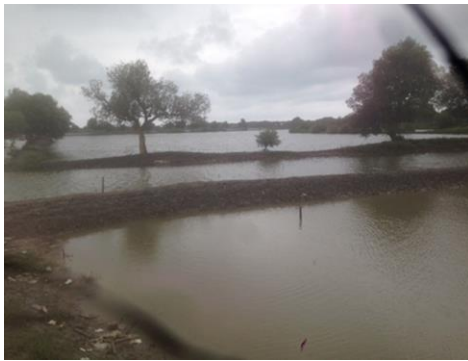
Figure 13. Brackish water ponds on the coast of Serang

Based on field observations conducted in February 2020, the conversions of coastal lands into brackish fishery ponds (Figure 13) had an impact on the condition of the shorelines in the area. Ponds and seas were only separated by strips of land (Figure 14). If the barriers were broken, seawater would merge with the ponds,

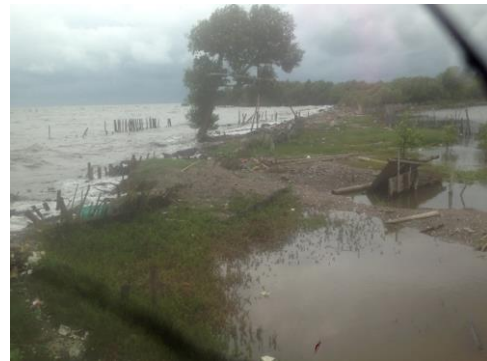
Figure 14. A narrow strip of land separating a pond and the sea

making more salt-water flow landward and erode the landmass further. Conversions into fishponds involved a reduction in coastal vegetation, especially mangroves. The small number of mangrove trees and other vegetation, the majority of which are shrubs, aggravate abrasions, as shown in Figure 15 (the retreat of the coastline left land plants immersed in the sea) and Figure 16 (a steep layer of soil indicated remains of erosion). Lack of coastal vegetation and low bulk density of soil were also unable to withstand tidal waves, which cause tidal flooding in the lower coastal plains (Figure 17). This matched with the observations from Setyawan (2010) in the same area, who states that ponds built-in coastal lands and very close to the shorelines leaving little or no mangroves, causing the vegetations to lose their ability to inhibit coastal erosions.

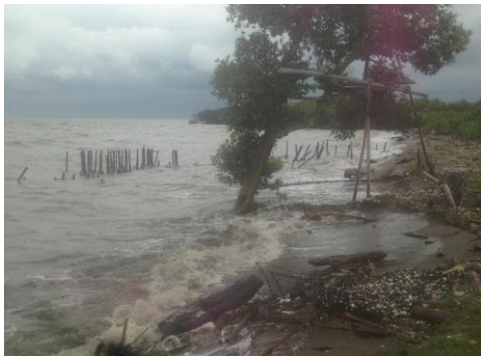
Figure 15. Abrasions left a tree immersed in the sea

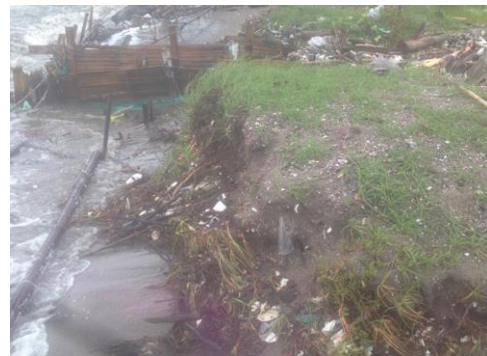
Figure 16. Steep layers of soil indicates eroded land

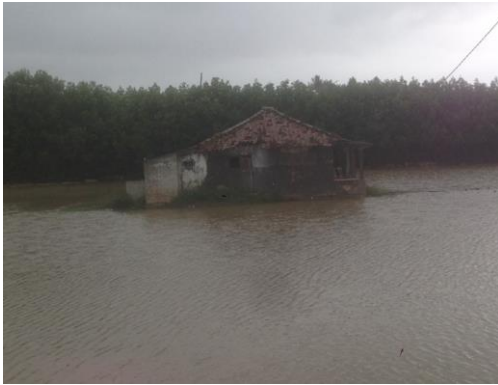
Figure 17. Tidal flooded coastal land

cause land subsidence to occur faster than the build-up of new soil layers by sediment deposits (Trujillo & Thurman, 2016). Land subsidence, absence of wave barriers, and sea-level rise (due to tides or due to climate change) are factors causing tidal flooding and retreating of the coastline, as observed at Pontang Cape.
